The Ridge Back Wall Repair Cover Page - DRAFT ONLY

1. Wall repair work.

A partial repair plan and a budget have been previously established. The intent of this report is to more fully grasp the total Wall "problem" and hopefully develop levels of wall repair solutions based on the severity of the structural concerns.

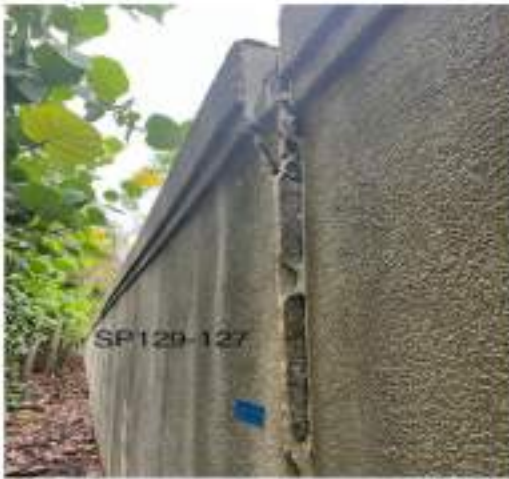
Level 1: High Structural Concern. Major cracks, gaps, leaning wall. Must address.

Level 1 - High - Structural Concern.

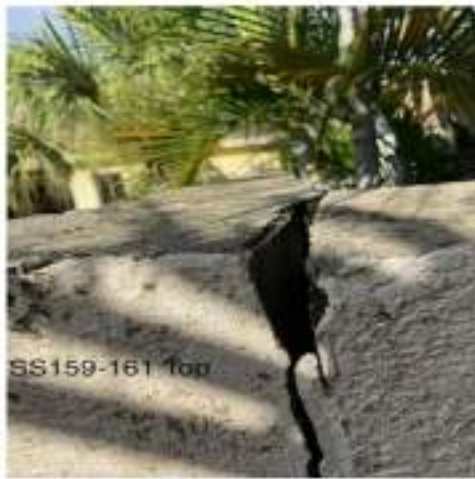
Level 2: High Concern. Significant cracks, gaps. Seek repair options.

Level 2 - Significant Concern

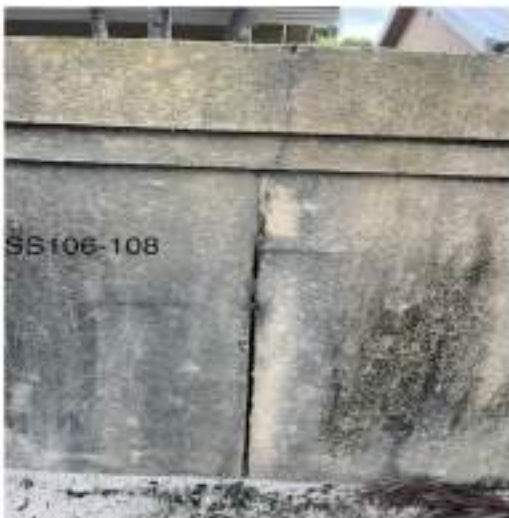
Level 3: Medium Concern. Cracks & gaps, but may have patch options.

Level 3 - Medium Concern. Repair asap

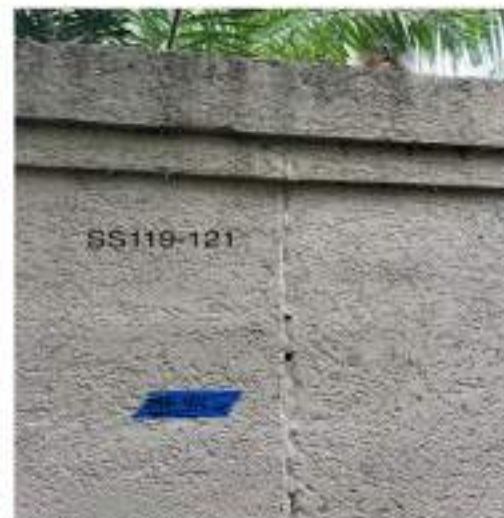
Level 4: Low Concern. Minor cracks. No shifting. Seemingly simple repairs.

Level 4 - Low Concern.
