The Ridge Back Wall Repair Cover Page - DRAFT ONLY

The intent of this report is to fully grasp the total backwall "problem" and develop levels of wall repair solutions based on the severity of the structural concerns.

Back Wall Repairs Primer Rev 1

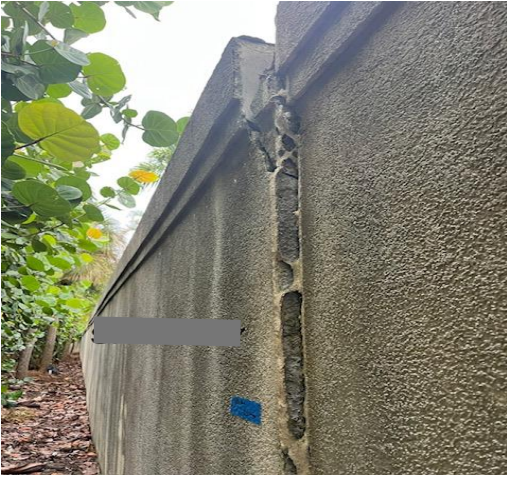
Level 1: High Structural Concern. Major cracks, gaps, leaning wall. Must address.

Level 1 - High - Structural Concern.

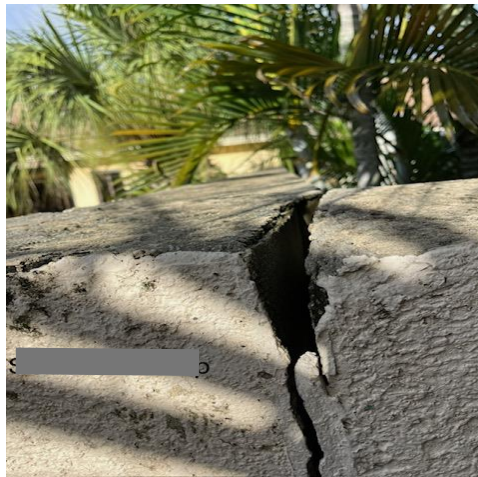
Level 2: High Concern. Significant cracks, gaps. Seek repair options.

Level 2 - Significant Concern

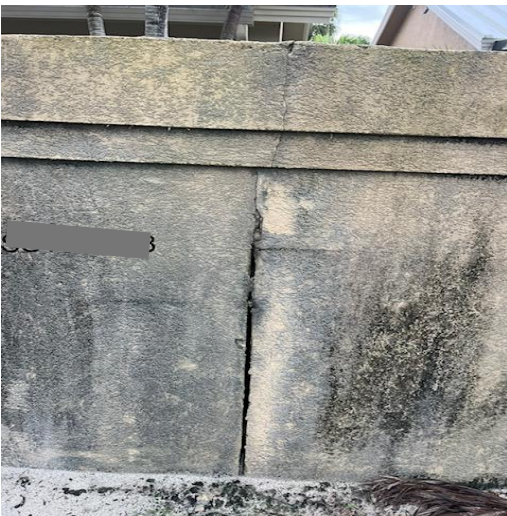
Level 3: Medium Concern. Cracks & gaps, but may have patch options.

Level 3 - Medium Concern. Repair asap

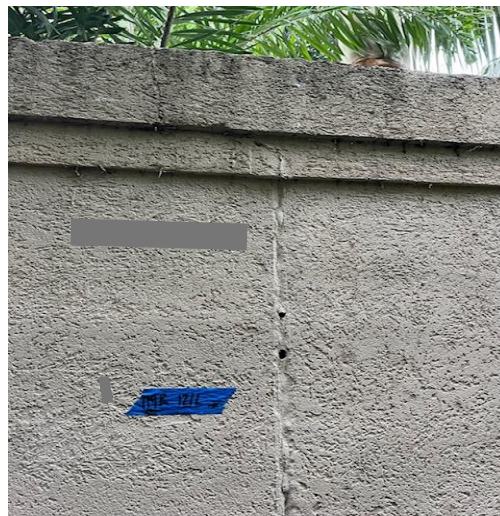
Level 4: Low Concern. Minor cracks. No shifting. Seemingly simple repairs

Level 4 - Low Concern.
